# BRITANNIA'S ENVIRONMENT

A look into the 20th century environmental legacy of the Britannia Mine and its 21st century clean up

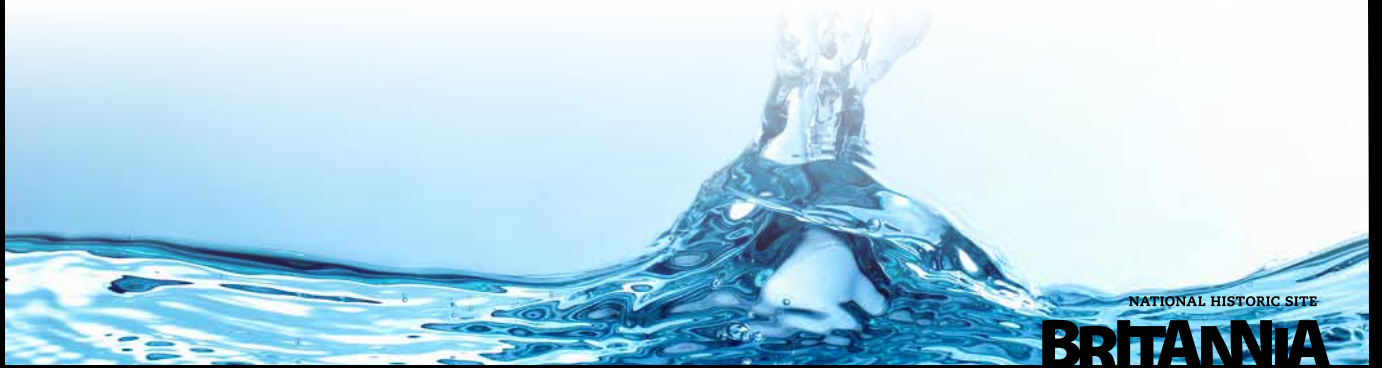
ARD production is a very complicated process, but the main reaction is:

play a big part in ARD production. The biggest ARD producer is pyrite (iron sulphide), though at Britannia, others include chalcopyrite (the copper ore), galena (lead) and sphalerite (zinc). A chemical reaction happens that produces sulphuric acid and dissolves metals, both of which pollute the local environment when they get into the groundwater and local water sources.

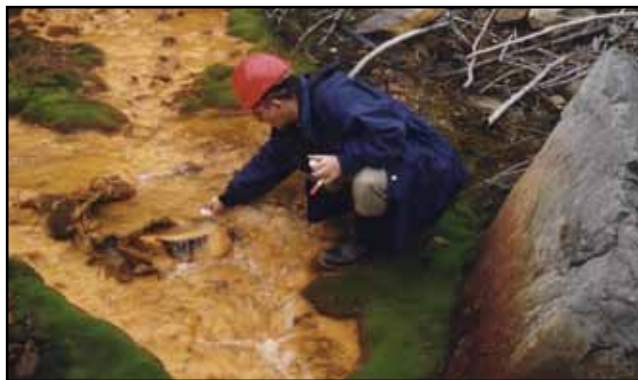
*The local creeks eventually became contaminated with iron hydroxide coatings called 'yellowboy'*

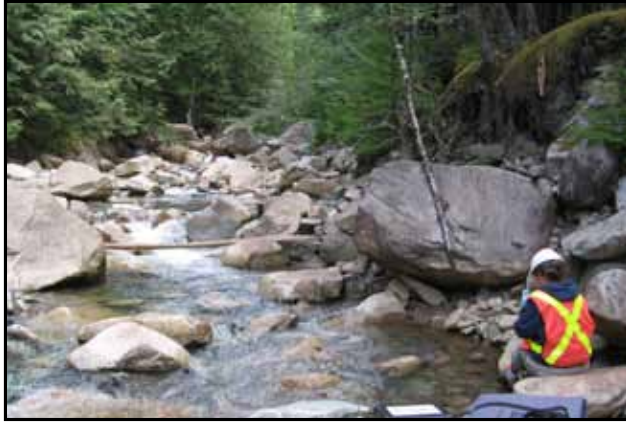
*Water sampling from Britannia Creek*

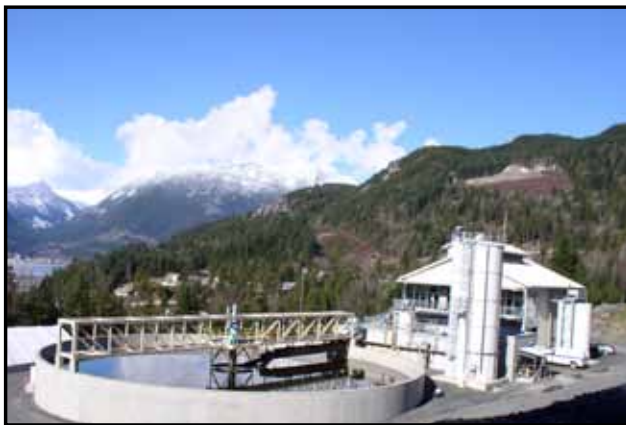
*EPCOR Britannia Mine Water Treatment Plant*

On arrival at the facility, the water is first treated with lime slurry (a mixture of lime and water) in two reactor tanks. The alkaline lime neutralizes the acidic water, quickly raising the pH from 3.8 (ARD) to 9.3. At pH 8.5, the dissolved metals naturally come out of

solution and precipitate as tiny particles. The most amount of metals precipitate at pH 9.3. The water is then fed into a large 'clarifier' tank where a customized, man-made polymer is added. This electrostatically attracts the metal particles, forming clumps that sink through their own weight, creating a dense sludge at the bottom of the tank. This is removed, and the clean water is discharged into Howe Sound. By the time the water reaches the sea, its pH has naturally decreased to around neutral. Some of the metal-rich sludge is added back into the lime and ARD mix. The sludge particles are a catalyst, encouraging the newly precipitated metals to stick to them – speeding up the precipitation/ clumping process. The rest of the sludge is dewatered in a large filter press (to 45% dry), then stored until it is taken back up to the original mining pit (Jane Basin) high on the mountain.
